THERMAL FATIGUE FAILURE IN BED EVAPORATOR TUBE OF AN AFBC BOILER

By K.K.Parthiban, B. Tech(IIT-Madras), M.E Thermal Engineering- RECT Trichy

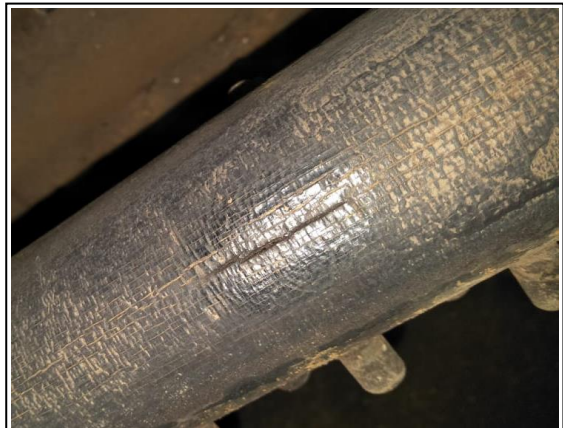
This paper is about a repetitive evaporator tube failure experienced in an AFBC boiler. The mode of a bed evaporator tube is generally erosion or overheating or water side corrosion. But this case was thermal fatigue. Photo 1 shows the alligator skin like appearance at the failed portion. Photo 2 shows the internal longitudinal chain of cracks at 12° clock position.

Photo 1: Cracks in the tube at top side

The failed tube showed multiple cracks on the top part of the tube. Studs are welded at the bottom and

the top is strained on thermal fatigue. There was intermittent flow inside the tubes in a cyclic manner. The cracks that have got initiated once due short overheating cycles, have grown to multiple cracks.

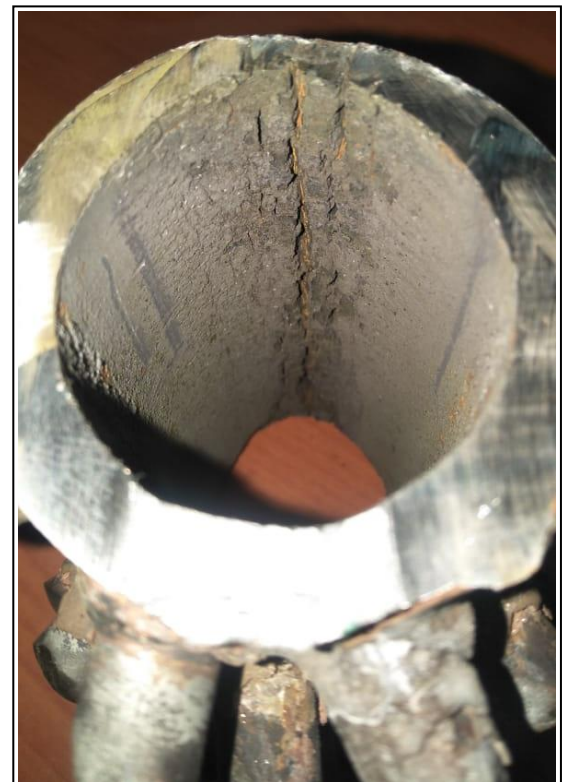
Photo 2: Inside of failed tube

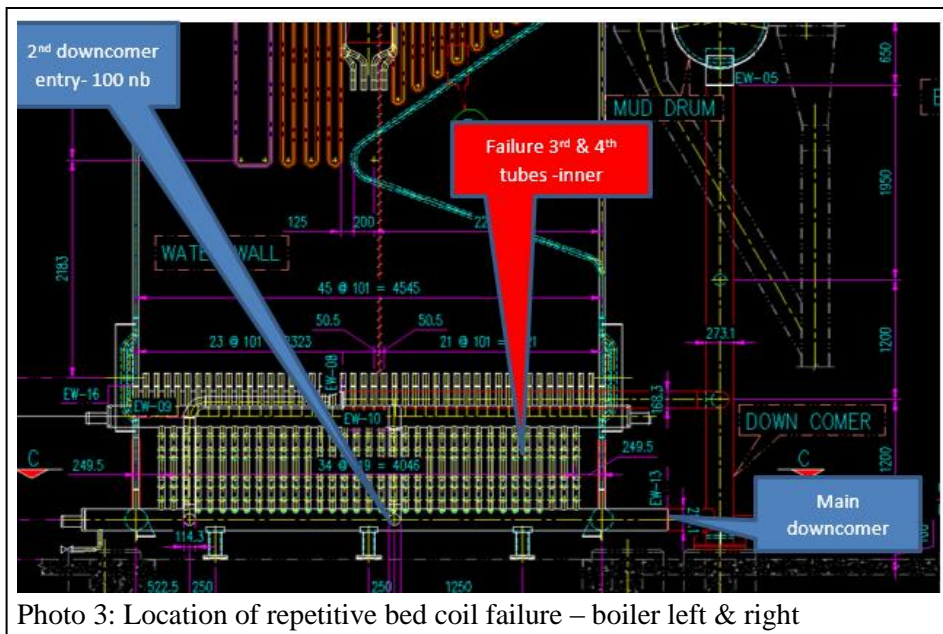
The failed tube locations are shown in photo 3. There are inner and outer tubes in this bed tube configuration. Only inner tubes failed.

Photo 3: Location of repetitive bed coil failure – boiler left & right

The reason for the inner coil to fail is the heat flux and its outlet arrangement. The outer tube gets little more heat. The inner coil length is 1516 mm and the outer coil length is 2162 mm. The steam generation in the outer coil is more. This can obstruct the flow rate in the inner coil due to arrangement of stubs in the bed coil outlet header. Every boiler will have a difference in flow in the set of parallel tubes. Overall circulation is different from individual circulation rate in the various tubes. In this boiler, the least flow occurs in the inner coils of 3-4-5-6 tubes from furnace rear wall.

We recommended a modification in feed distributor pipe to get subcooled water to the positive downcomer zone. This was incorporated immediately by the boiler supplier.

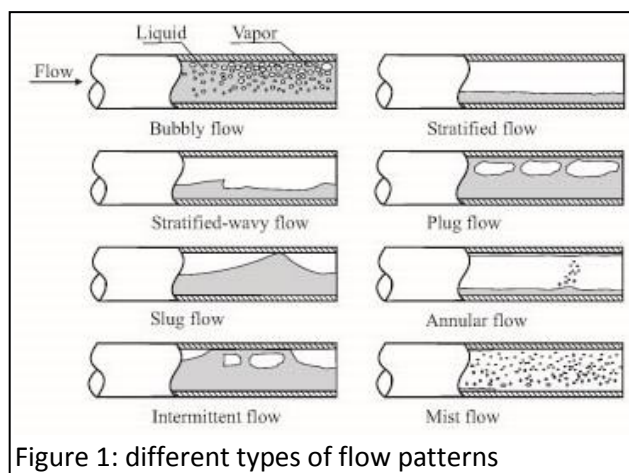
down of protective iron oxide exposing bare metal. The heating and cooling cycles repeat due to fluctuations in circulation rate. The flow tends to be intermittent as shown in figure 1. The flow rate of water inside the tubes must be changing in a cyclic manner. Normally when the starvation is sustained, the tube fails by overheating / creep mechanism. When there are cycles, fatigue is the failure mechanism.

Figure 1: different types of flow patterns

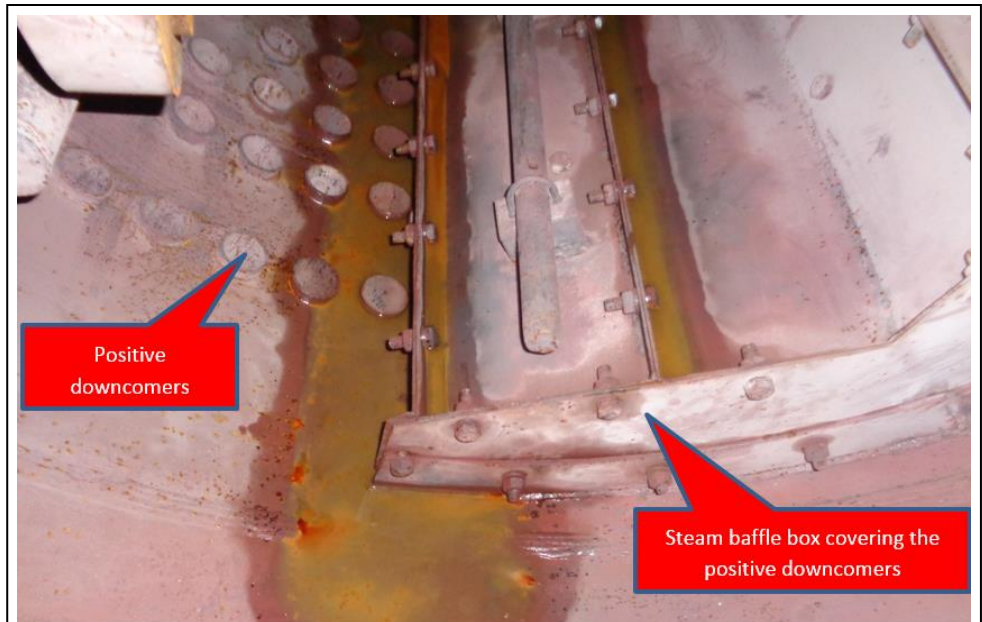
Photo 4: Positive downcomers in the steam drum

Steam drum & water drum were inspected. There was a defect in steam drum internal. The positive downcomers in the front side boiler bank tubes were covered under the baffle box. See photo 4 above. The positive downcomers are insulated from heat input, by brick work in the gas path. See photo 5. Baffle box is a place where steam water mixture is available. Hence the overall circulation rate is reduced. The 180-rear set of tubes act as downcomers normally. By normal heat pick up, these are downcomers, as the water inside does not reach boiling state. The steam drum baffle was corrected in this visit itself.

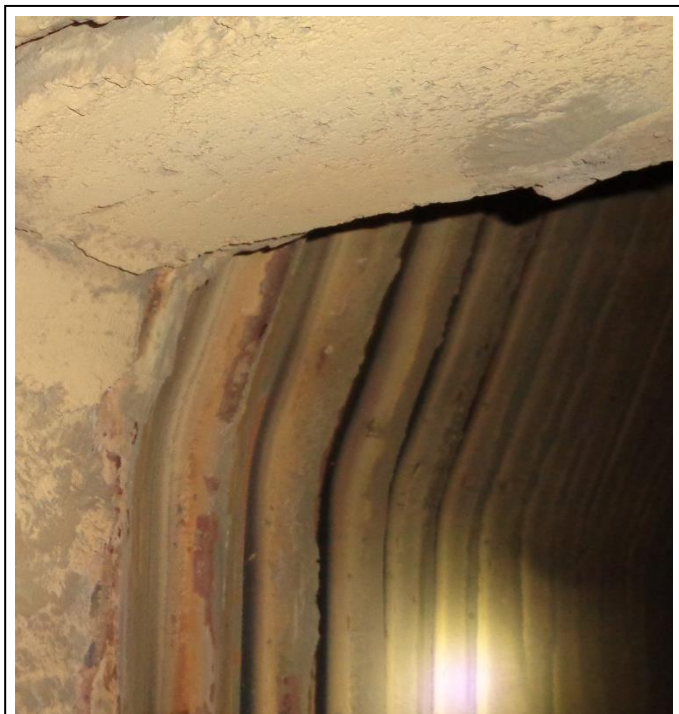
Photo 5: Brick work insulating the end bank tubes

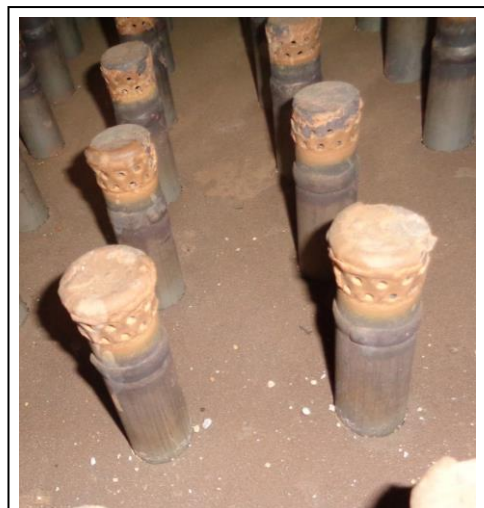
The boiler engineers showed some photos taken during shut down. The bed coil studs were found coated with slag. The air nozzles were seen capped with molten ash. This is due to low AFT of the ash of Indonesian coal. There are some important things to be taken care in Indonesian coal usage.

Photo 6: Plugged air nozzles

- Coal should be procured with AFT above 1300°C.
- Iron in bed ash should be less than 10%. This is to be checked by magnet. It is necessary to start the boiler with fresh bed material. From day one, the iron should be monitored, by frequent bed draining and replacing with iron free bed ash. Magnetic drums are used for this purpose.
- Bed ash bulk density should be below 1400 kg/m³. The bulk density of fresh bed material is generally around 1100 -1200 kg/m³.
- Fines and volatile matter in Indonesian coal lead to high flame at fuel feed points. Bed should be drained from all drain pipes. Compulsory draining is required at all drain points.

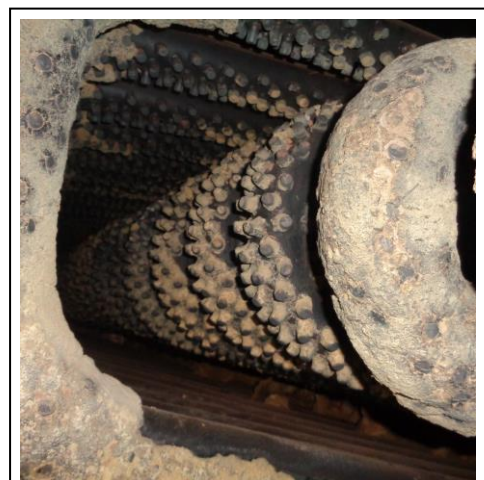
Photo 7: Ash slag over bed coil studs

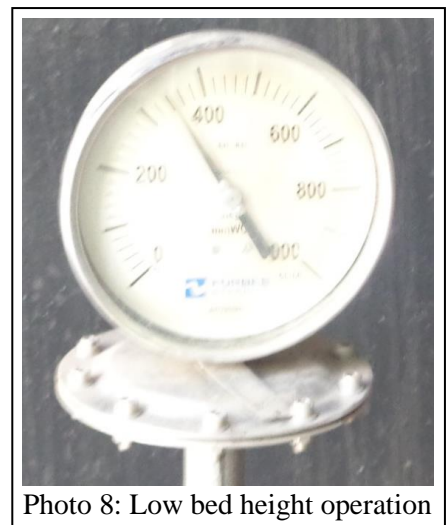
Photo 8: Low bed height operation

8. All operators learnt the advantage of the deeper bed of 425 mmWC. The bed height must be increased slowly without dropping the bed temperature excessively. The bed material gate at bed material bunker should have a hole of 50 mm only so that the feed rate is minimum & controlled. The bed inventory should be more or less constant, like boiler drum level. This is the key to stability of the combustion in AFBC / CFBC boilers. Flue gas does not transfer heat directly to bed coil. It is the bed material that transfers the heat to the bed coil. Less bed height causes erratic combustion.

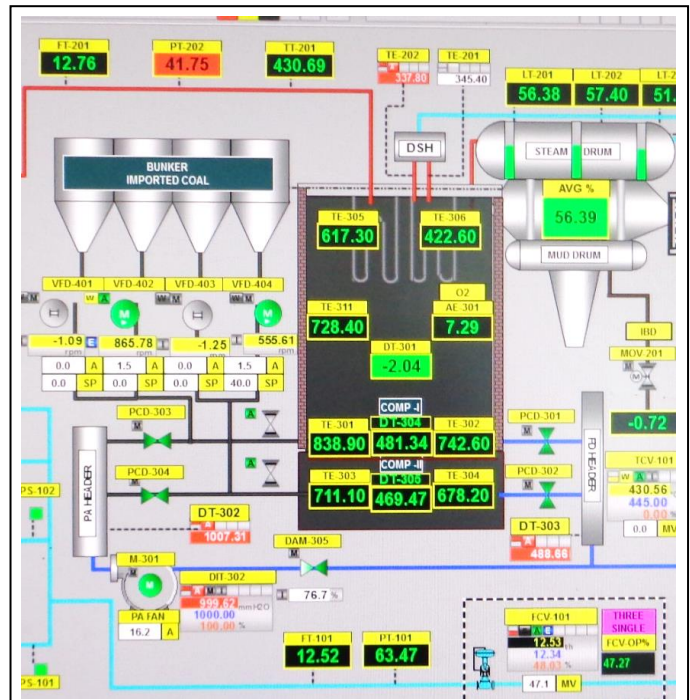
3. Around 12 noon, pulp section was stopped. The boiler load was at 12 TPH. The coal feed rates of compartments were varied without a basis by the boiler operators. In 1st compartment, the feeder rpm was at 709 and in the 2nd compartment the rpm was at 275. The fuel input to the 2nd compartment was being varied quite a lot. The steam pressure was not under control at all. The bed temperatures in 1st compartment were at 866 °C & 738°C. The bed temperatures in 2nd compartment was at 760 & 698 °C. It was explained to boiler operators, that less bed height would cause this. It was not a correct practice to vary the feeder rpm only in 2nd compartment. It was learnt that all along this was the operational practice. That answered the cycles of circulation disturbance. Every time when the firing is reduced, the heat input is reduced in 2nd compartment; the circulation gets reduced. The circulation takes time to establish back, when the coal feed is increased. This frequency was high enough to have thermal fatigue. However, FCV % opening was good with 3 element control.

Photo 9: Different coal feed rpm & bed temp difference

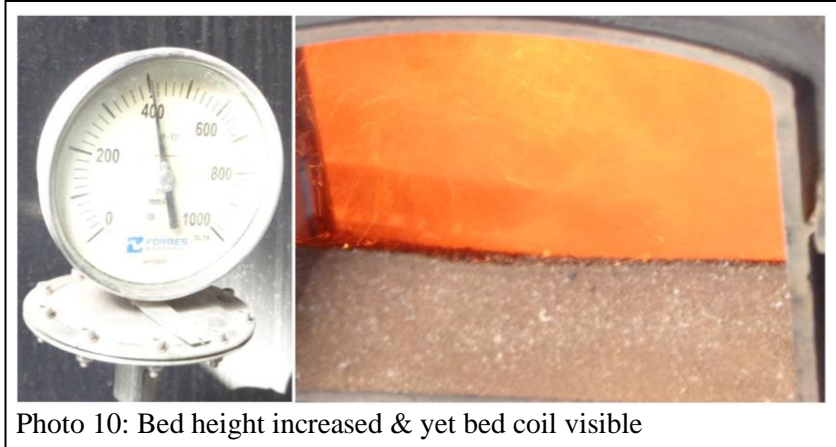
5. The bed height was increased to 400 mmWC. As the bed material feed rate was high, the bed temperature dropped too much. It was advised to throttle the gate below bed material bunker. The rear door was opened to see the immersion. 3/4th of the top part of the outer bed coil was visible. See photo 10. The bed height could be further increased. It was flameless combustion, which is the characteristics of fluidised bed.

Photo 10: Bed height increased & yet bed coil visible
